# Culture, Parks & Recreation Department (CPRD)

Comprehensive Master Plan-Appendix C

Design Recommendations and Opinions of Probable Cost (Rough Orders of Magnitude)

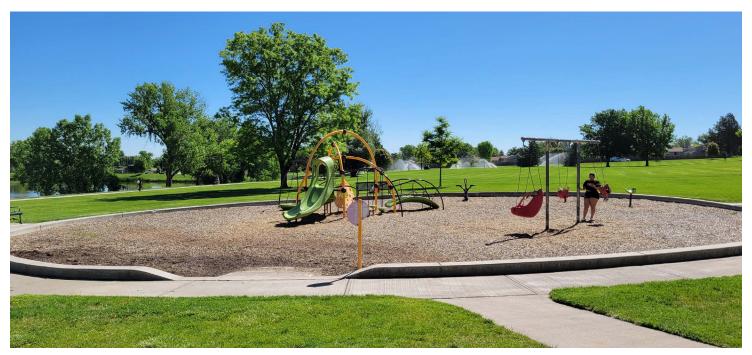
BITTERSWEET 1A - Existing eastern playground area.

CPRD Team Input	Design Team Recommendations
None.	GENERAL  1 - Include playground in the system life-cycle replacement program (medium priority, replace in 5-10 years) to allow City to prioritize enhancements and budget for equipment over time.  [PHOTOS 1A, 1B, 1C, 1D]
	IMPROVEMENTS  1 - Redesign southern parking lot and basketball court area to create a better sense of arrival to park.  [PHOTO 2]
	2 - Add shaded seating and perimeter fencing at the basketball courts to improve overall visitor experience. [PHOTO 3]
	3 - Provide more shade at playgrounds to reduce sun exposure to children and improve overall visitor experience. [PHOTOS 1A, 1B, 1C, 1D]
	4 - Provide programmed water access (i.e., piers) to improve overall user experience. [PHOTOS 4A, 4B]
	MAINTENANCE 1 - Repave parking lots. [PHOTOS 5A, 5B]
	2 - Repair cracked sidewalks. [PHOTO 6]
	3 - Correct ponding at playground. [PHOTO 7]
	4 - Reestablish turf in the northern "Grasspave" access drive. [PHOTO 8]

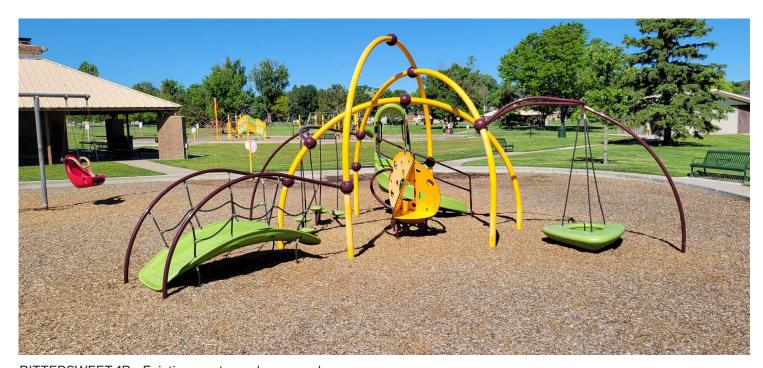
BITTERSWEET 1B - Existing eastern playground area.

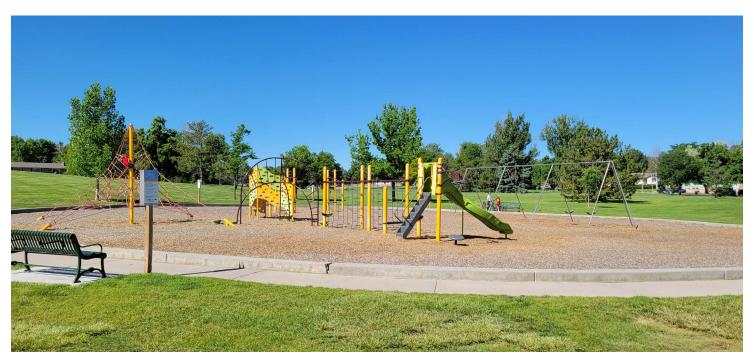
BITTERSWEET 1C - Existing western playground area.

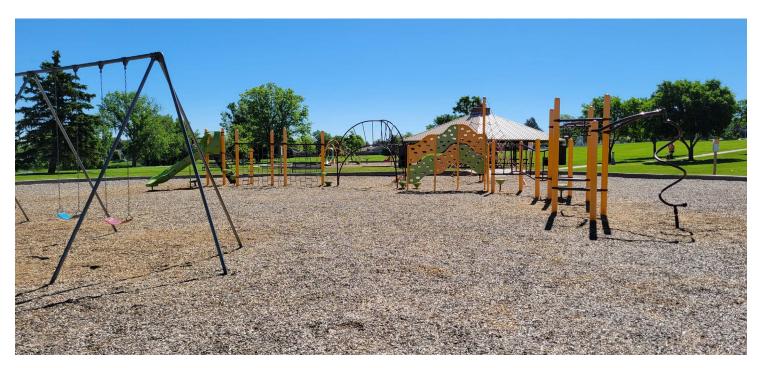
BITTERSWEET 1D - Existing western playground area.

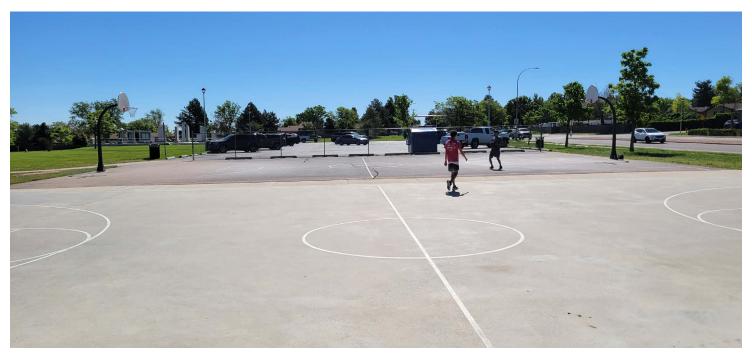
BITTERSWEET 2 - Existing concrete basketball court (foreground) and asphalt basketball court (background).

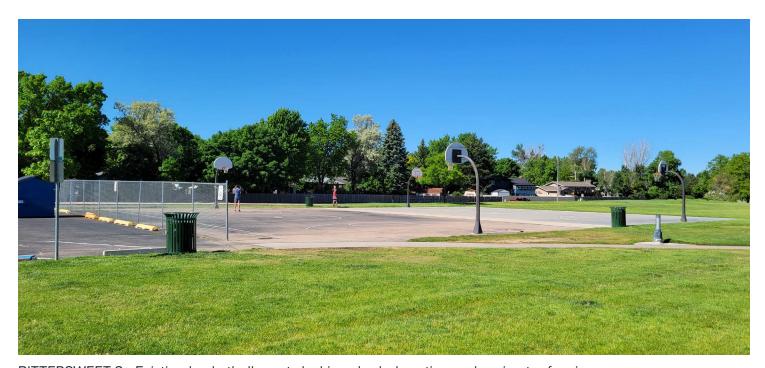
BITTERSWEET 3 - Existing basketball courts lacking shaded seating and perimeter fencing.

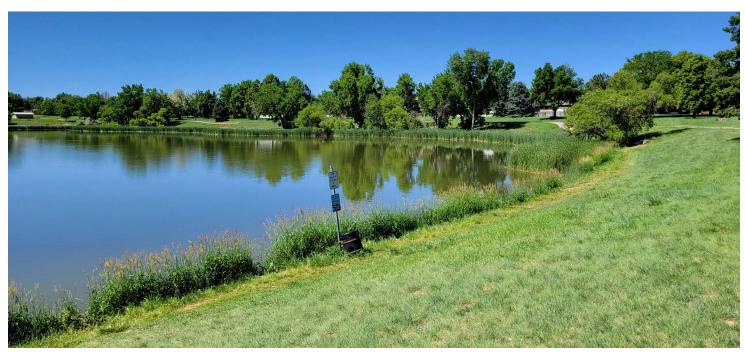
BITTERSWEET 4A - Northern bank of pond lacking programmed water access (view to southwest).

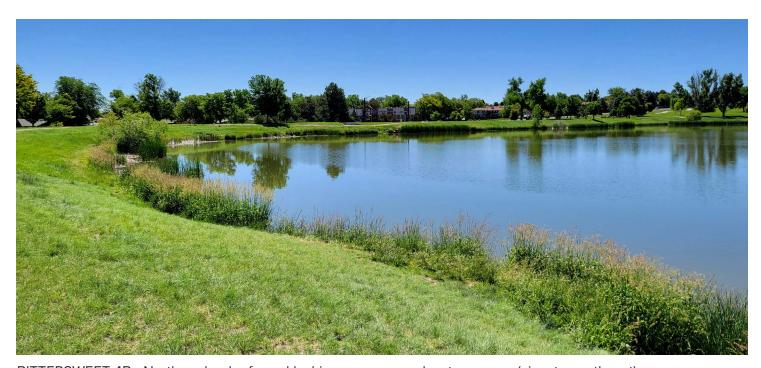
BITTERSWEET 4B - Northern bank of pond lacking programmed water access (view to southeast).

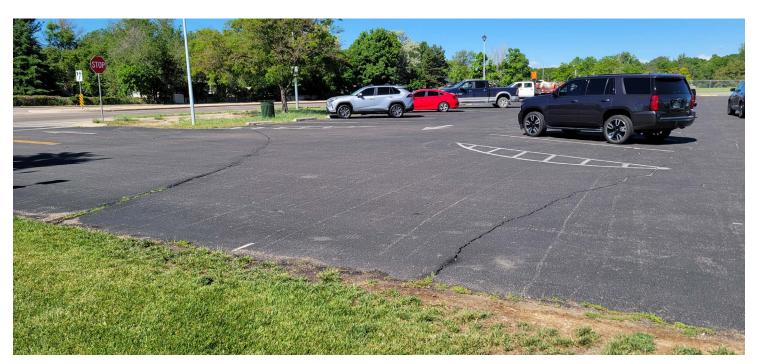
BITTERSWEET 5A - Existing southern parking lot in need of repavement.

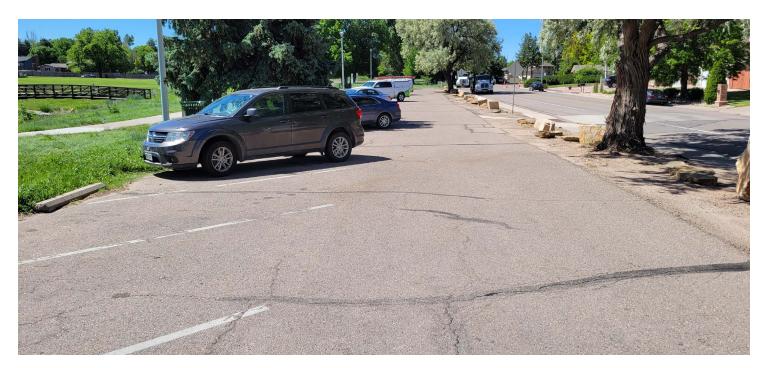
BITTERSWEET 5B - Existing western parking lot in need of repavement.

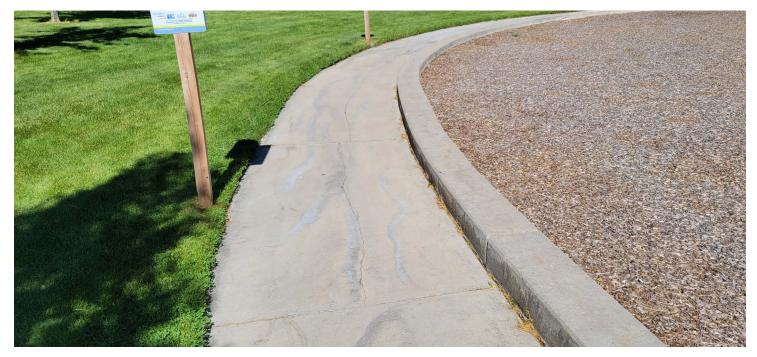
BITTERSWEET 6 - Example of cracked sidewalk near western playground area.

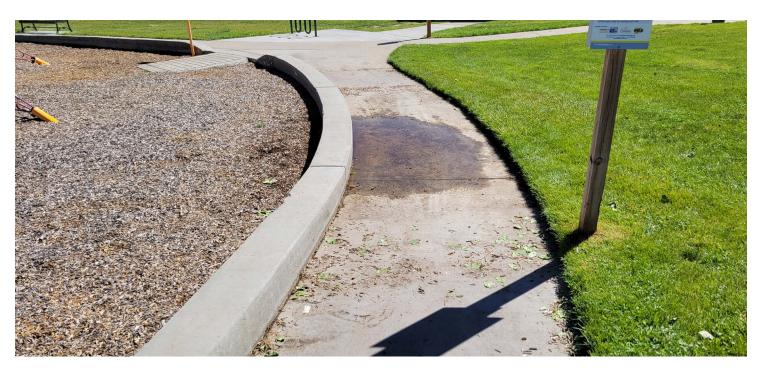
BITTERSWEET 7 - Example of ponding on sidewalk near western playground area.

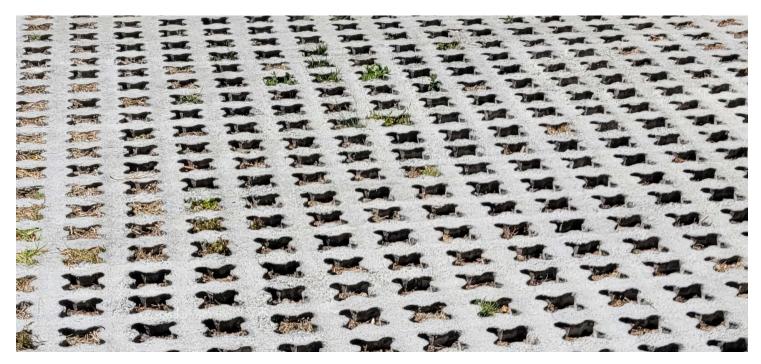
BITTERSWEET 8 - Existing "Grasspave" area lacking turf.

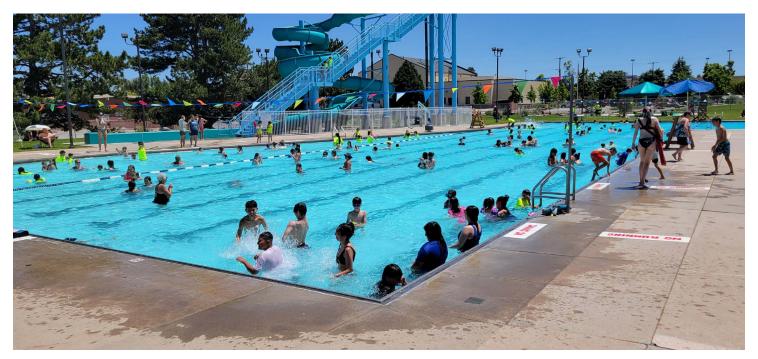
CENTENNIAL POOL 1 - Existing pool in need of repairs and deepening for competitions.

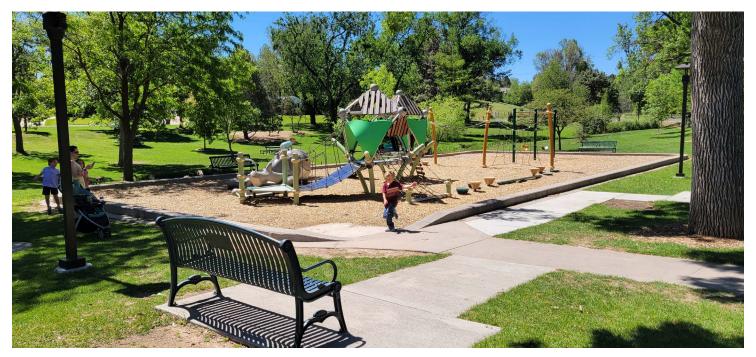
GLENMERE 1A - Existing playground area (in need of shading).

CPRD Team Input	Design Team Recommendations
None.	GENERAL  1 - Include playground in the system life-cycle replacement program (low priority, replace in 10+ years) to allow City to prioritize enhancements and budget for equipment over time.  [PHOTOS 1A, 1B]
	IMPROVEMENTS  1 - Provide more shade at playground to reduce sun exposure to children and improve overall visitor experience.  [PHOTOS 1A, 1B]
	2 - Naturalize pond edge near pavilion (i.e., replace concrete) to improve park aesthetic. [PHOTO 2]
	3 - Add seating in pavilion to improve overall visitor experience. [PHOTO 3]
	MAINTENANCE  1 - Eradicate algae from the small pond. [PHOTO 4]
	2 - Implement erosion control measures along channel. [PHOTO 5]
	3 - Replace wooden boards on bridge deck. [PHOTO 6]

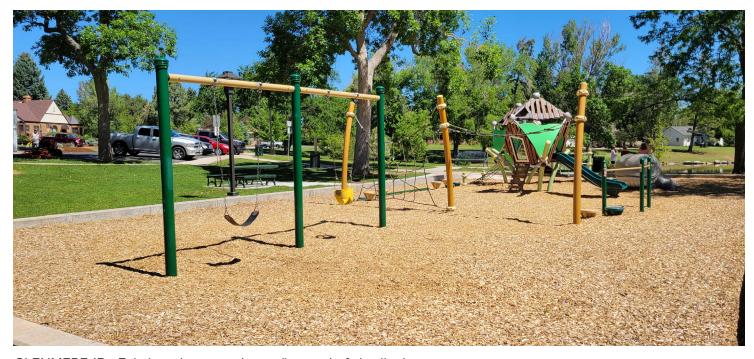
GLENMERE 1B - Existing playground area (in need of shading).

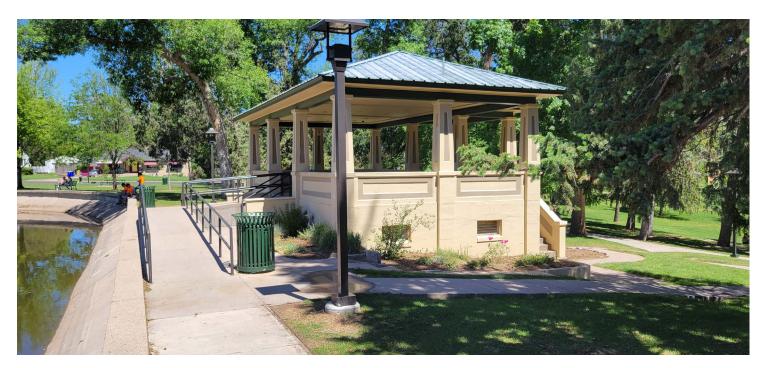
$\label{eq:GLENMERE 3 - Existing pavilion lacking seating.}$

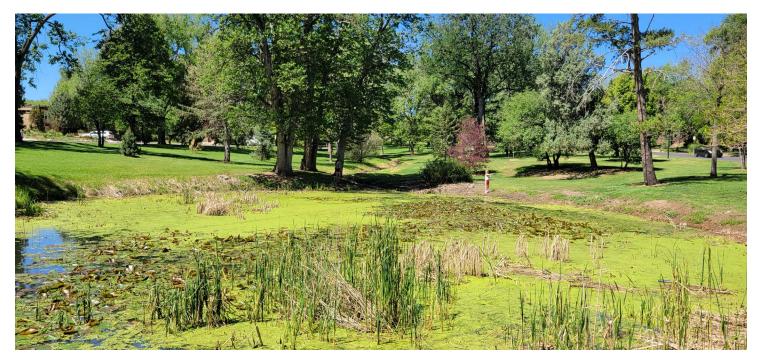
GLENMERE 4 - Algae-ridden pond.

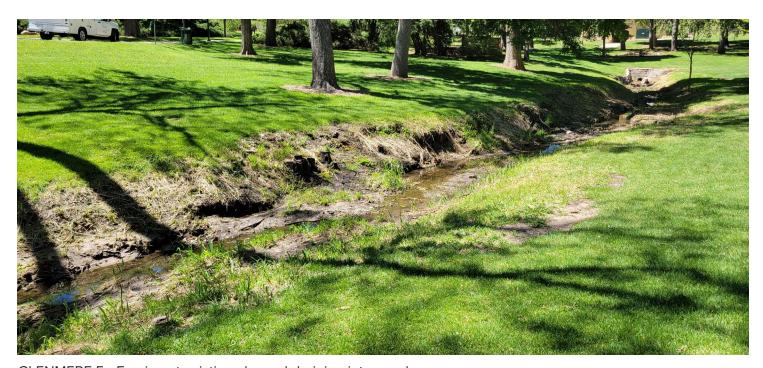
GLENMERE 5 - Erosion at existing channel draining into pond.

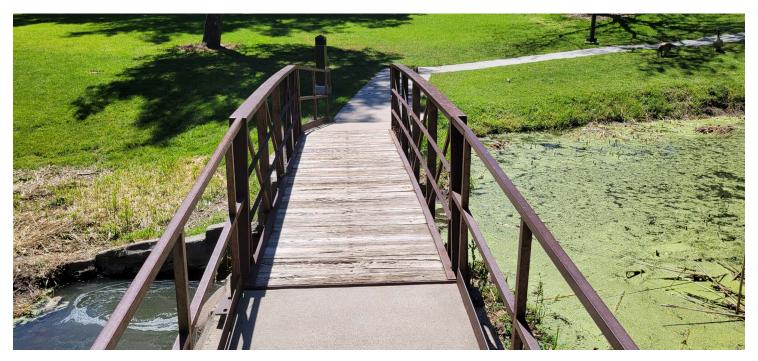
GLENMERE 6 - Existing bridge with worn decking.

No.	Item	Replacement Year	Item Notes	Qty.	Unit	Unit Cost	Subtotal
2.1	BRIDGE DECK		2X6 CEDAR PLANKING	75	SF	\$6.00	\$450.00

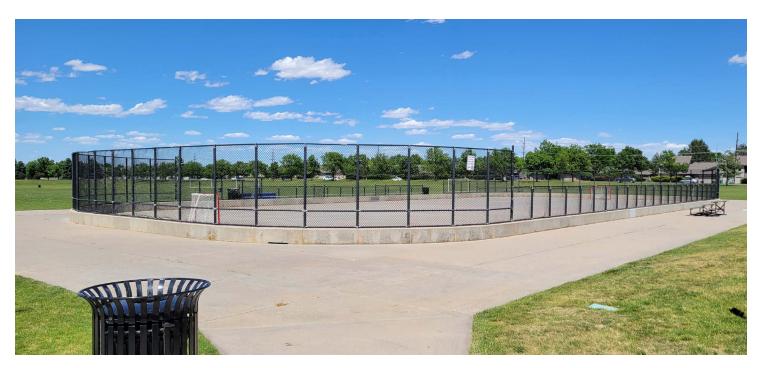
MONFORT 2 - Existing roller rink (in need of seating and shading).

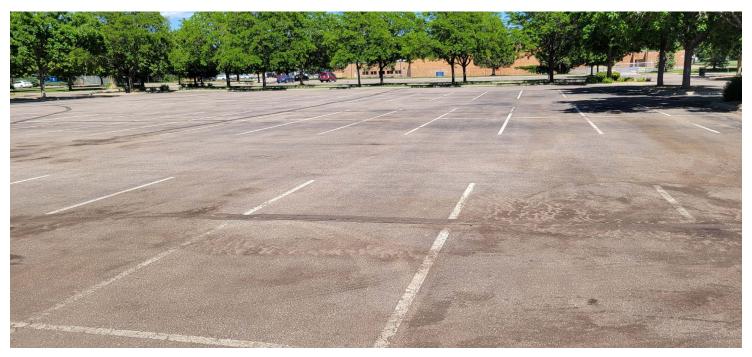
MONFORT 3A - Existing northern parking lot in need of repavement.

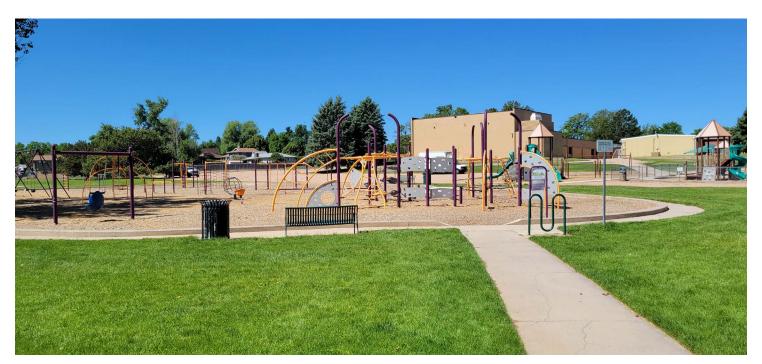
SHERWOOD 1A - Existing playground area (in need of shading).

CPRD Team Input	Design Team Recommendations
None.	GENERAL  1 - Include playground in the system life-cycle replacement program (medium priority, 5-10 years) to allow City to prioritize enhancements and budget for equipment over time.  [PHOTOS 1A, 1B, 1C]
	IMPROVEMENTS  1 - Replace asphalt basketball court pavement with post-tension concrete for more durability (scheduled for 2025).  [PHOTO 7]
	2 - Incorporate general diamond field improvements (dugouts, bleachers) to improve overall visitor experience. [PHOTO 3]
	3 - Remove excess pavement by playground. [PHOTO 2]
	4 - Provide more shade at the playground to reduce sun exposure to children and improve overall visitor experience. [PHOTOS 1A, 1B, 1C]
	5 - Consider redesigning the eastern parking area to provide additional parking (need exceeds current capacity and visitors are parking along alleyway). [PHOTOS 5]
	6 - Provide shaded seating at pickleball courts to improve overall visitor experience. [PHOTO 9]

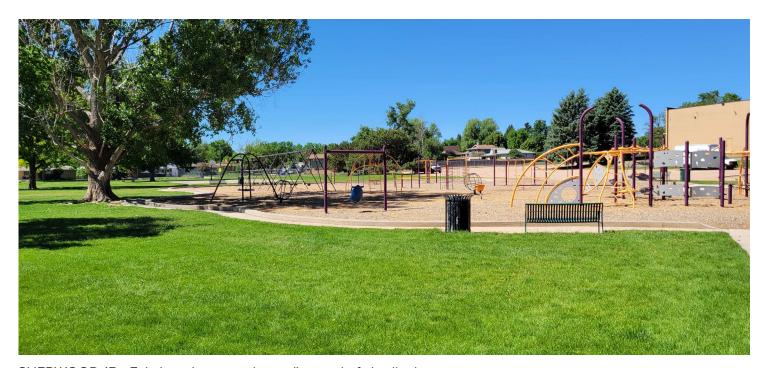
SHERWOOD 1B - Existing playground area (in need of shading).

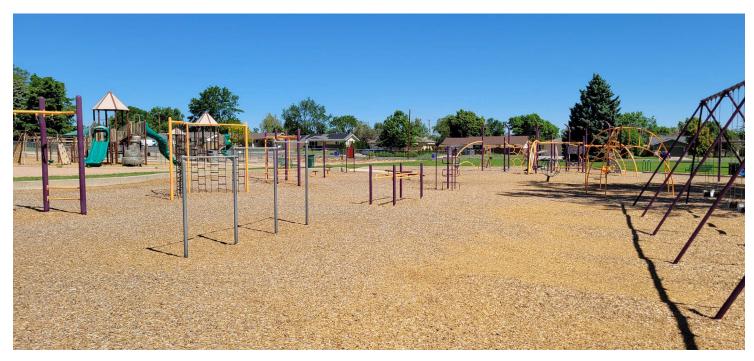
SHERWOOD 1C - Existing playground area (in need of shading).

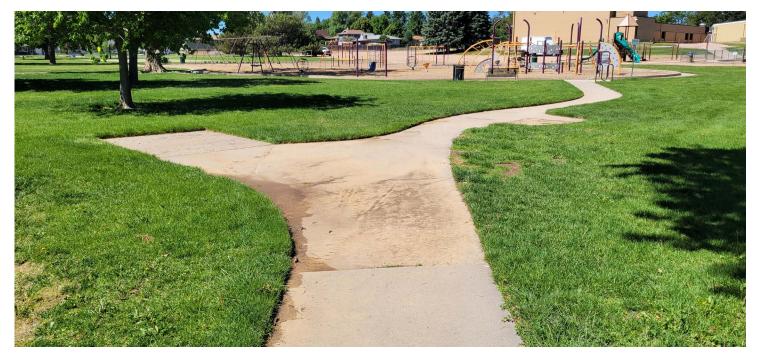
SHERWOOD 2 - Excess pavement (to left of sidewalk) near playground.

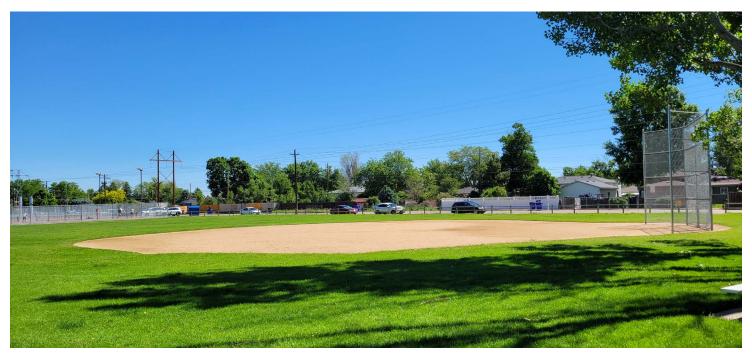
SHERWOOD 3 - Existing diamond field lacking dugouts and designated seating areas.

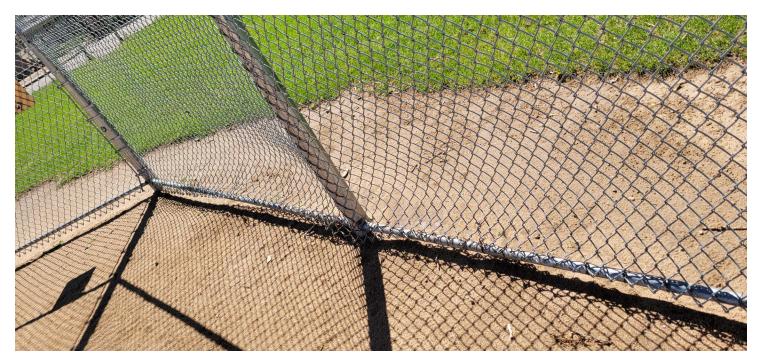
SHERWOOD 4 - Worn backstop fencing in need of replacement.

7 - Provide shaded seating at basketball court to improve overall visitor experience. [PHOTO 7]
	MAINTENANCE 1 - Replace backstop fence fabric. [PHOTO 4]
	2 - Replace basketball backboards/goals (scheduled for 2025). [PHOTO 8]
	3 - Repair or replace wooden fence. [PHOTO 6]
	4 - Correct ponding issues along pathways. [PHOTO 10]

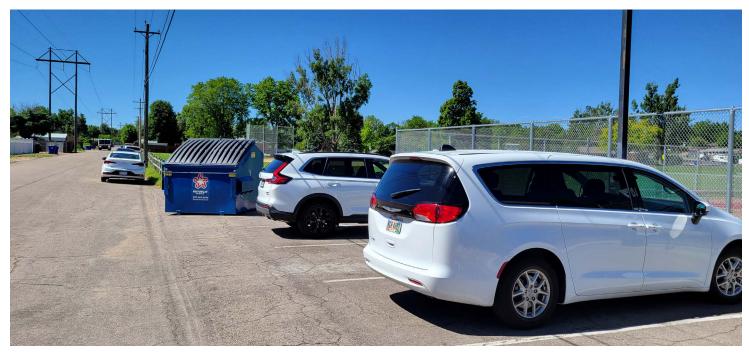
SHERWOOD 5 - Eastern parking area near pickleball courts in need of re-design.

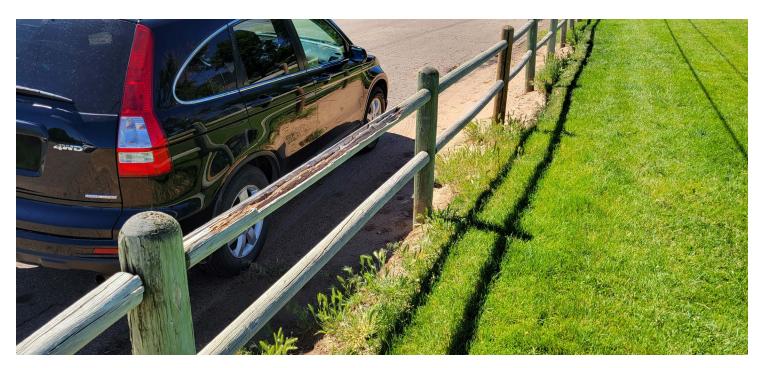
SHERWOOD 6 - Wooden fence in need of replacement (near eastern parking area).

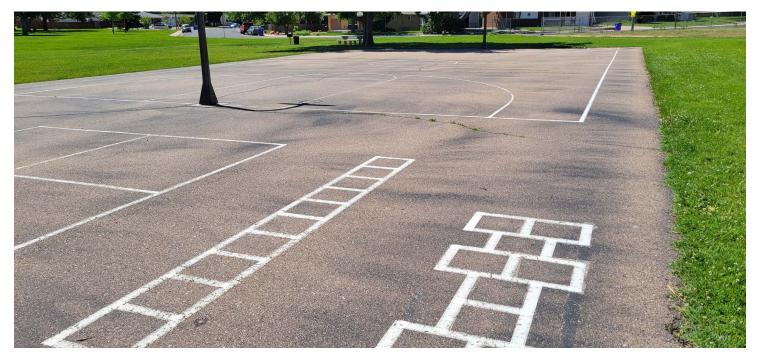
SHERWOOD 7 - Close-up of existing asphalt surface.

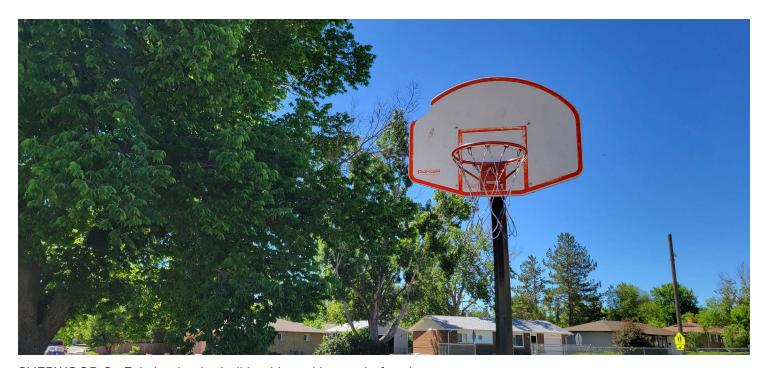
SHERWOOD 8 - Existing basketball backboard in need of replacement.

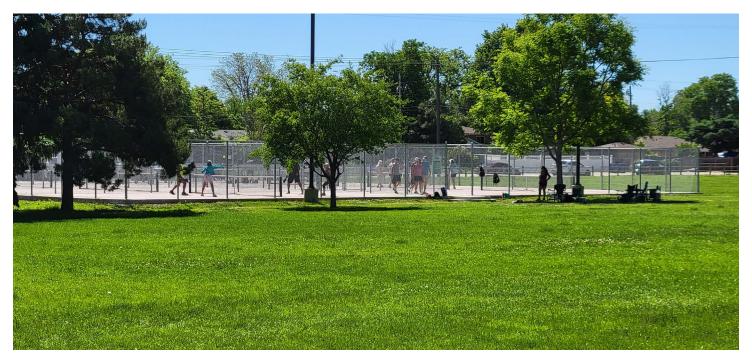
SHERWOOD 9 - Existing pickleball courts lacking designated seating.

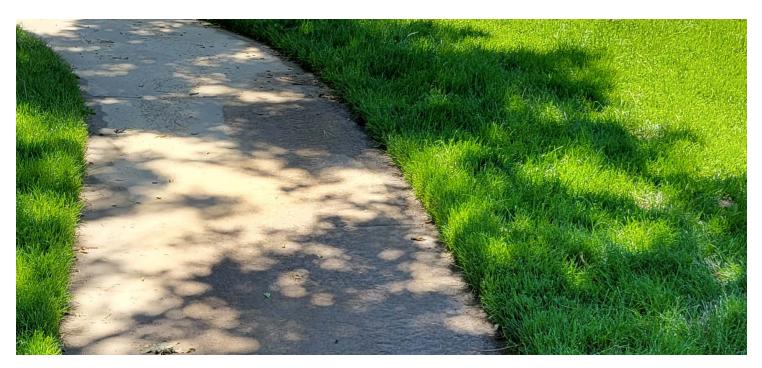
SHERWOOD 10 - Indication of ponding along pathways.

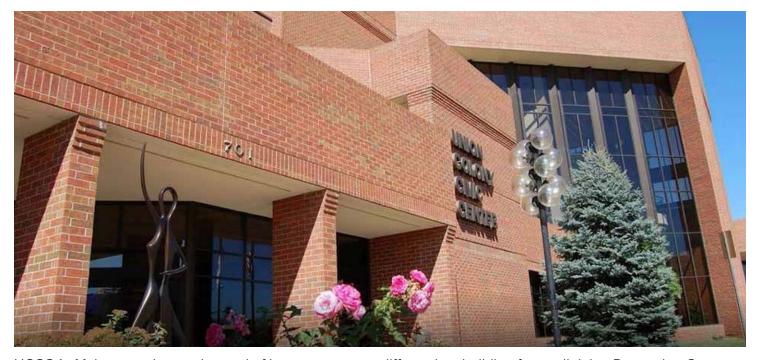
UCCC 1 - Main entry signage in need of improvements to differentiate building from adjoining Recreation Center.

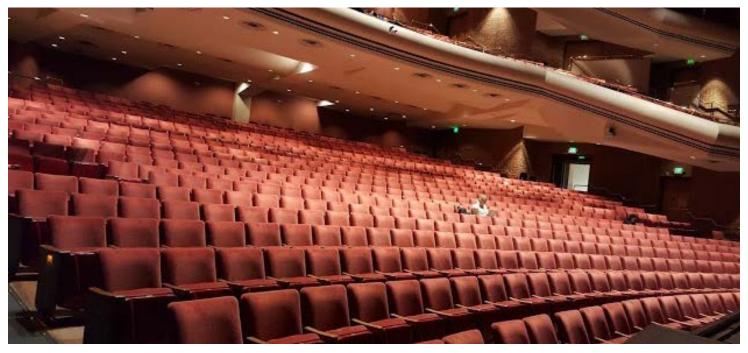
UCCC 2 - Theater seating in need of upgrade.

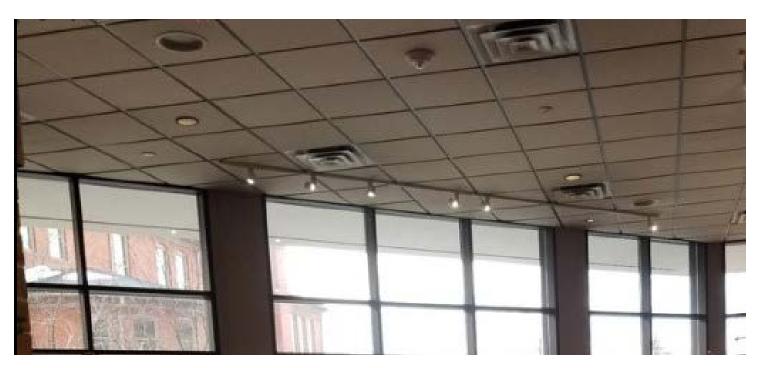
UCCC 3 - Water-damaged lobby ceiling in need of repair.

CPRD Team Input	Design Team Recommendations
To create more recognition, staff expressed interested in updating and redesigning the UCCC and renaming the facility. Consideration is also being given to redesigning the courtyard for improved utilization and reconfiguring outdoor spaces to create a stronger connection with Lincoln Park and the Farmers' Market. UCCC theater seats need to be reupholstered or redesigned.  Please refer to Facility Assessment accompanying this report.	GENERAL  1 - Internally assess facility vision, program, operations, facility conditions, opportunities/limitations, etc  2 - Engage planning/design professional to facilitate a re-visioning and master re-design effort that focuses on establishing an updated identity/brand and wayfinding needs.  IMPROVEMENTS  1 - Renovate courtyard and its connections to adjacent spaces.  2 - Upgrade overall finishes, particularly in theater greenrooms.  3 - Redesign lobby layout and finishes to provide a fresh and more updated appearance.  4 - Implement wayfinding redesign to differentiate the building from the Recreation Center as well as improve ability to locate entrances and navigate the building.  [PHOTO 1]  5 - Upgrade seating.  [PHOTO 2]  MAINTENANCE  1 - Update finishes throughout the building.  2 - Upgrade stage elevator and flooring.  3 - Replace water-damaged ceiling in the lobby.  [PHOTO 3]

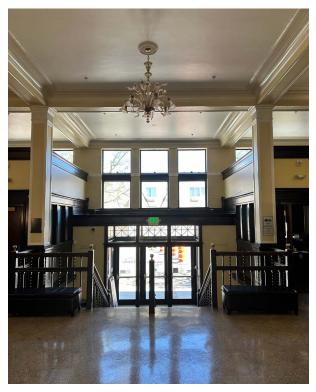
HISTORY MUSEUM 1 - Entry lobby space in need of more light.

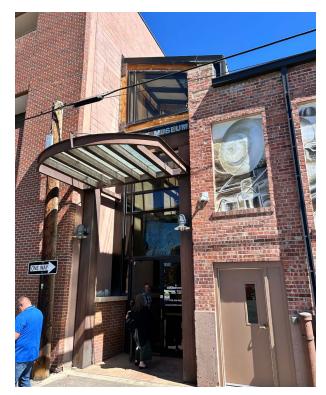
HISTORY MUSEUM 3 - South entry in need of re-design.

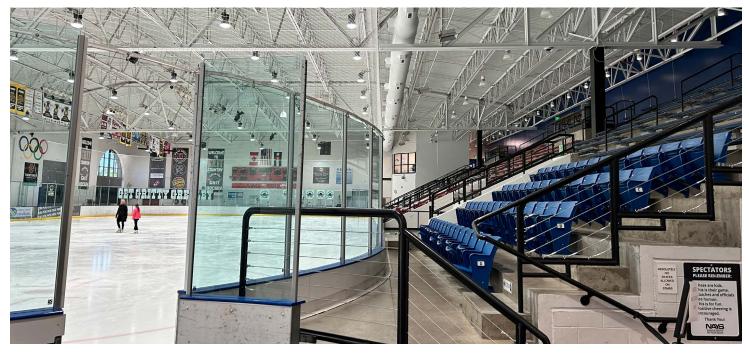
ICE HAUS 1 - Existing viewing area in need of additional seating.

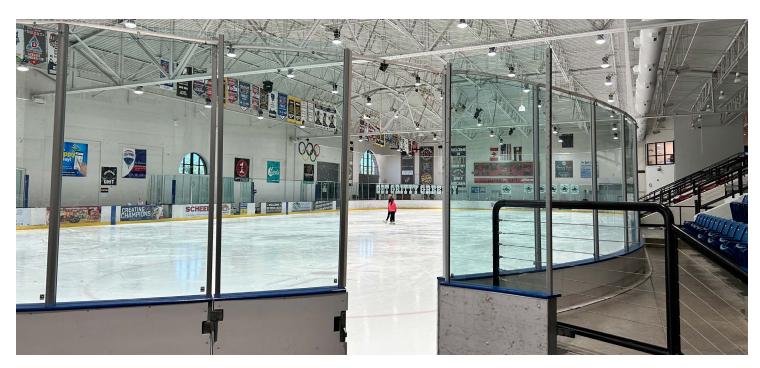
ICE HAUS 3 - Existing rink in need of new training area.

CPRD Team Input	Design Team Recommendations
Internally assess and consider a master redesign effort focused on expanding the facility to accommodate demand, upgrade the mechanical system, and address need for additional storage.	GENERAL  1 - Internally assess facility vision, program, operations, facility conditions, opportunities/limitations, etc.  2 - Engage planning/design professional to facilitate a re-visioning and master re-design effort that focuses on expanding the facility.  IMPROVEMENTS  1 - Replace mechanical equipment (current equipment is based on the original, larger design that included two sheets of ice; rather than be more efficient, this large systems causes excessive wear and tear).  2 - Provide additional ice sheet to accommodate demand (consider expansion into the adjacent parking lot that is underutilized).  3 - Provide additional seating.  [PHOTO 1]  4 - Provide additional office space at upper-level.  [PHOTO 2]  5 - Provide new ice training area.  [PHOTO 3]  MAINTENANCE  None.

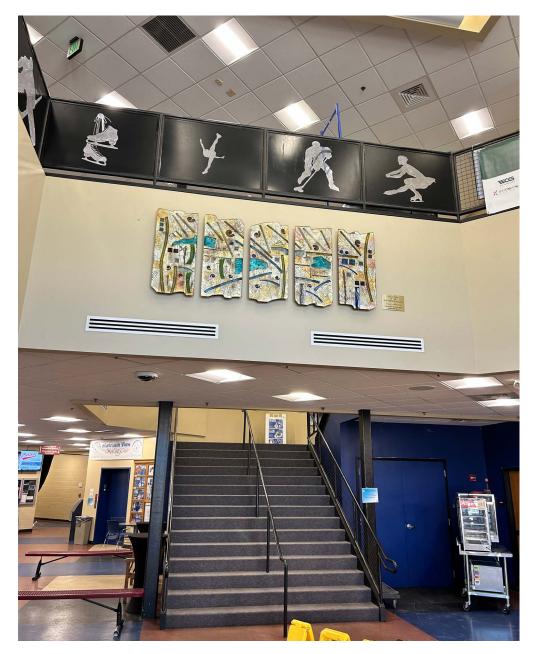
ICE HAUS 2 - Access to upper level that maintains opportunity for additional office space.
