# **Culture, Parks & Recreation Department (CPRD)**

## **Comprehensive Master Plan—Appendix B Facility Assessment**

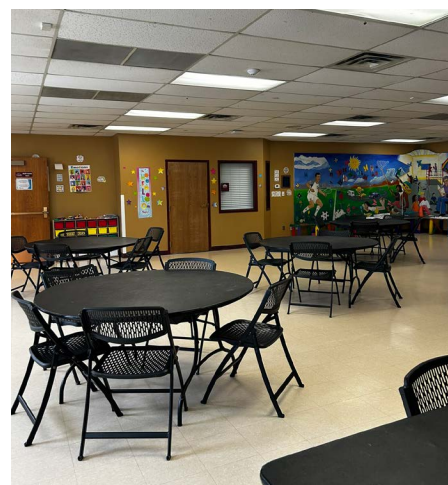
MULTIPURPOSE ROOM

Flooring: Carpet flooring in the ill-child room and the classroom/library should be replaced with a durable, easier-to-clean alternative. VCT flooring in the multipurpose room and STEAM classroom is worn and should be replaced.

Ceiling Finishes: The ceiling in the classroom/Library should be replaced with a lay in ceiling to help with acoustics and update lighting. Staff stated the multipurpose room ceiling and lighting are scheduled to be updated. The finishes in this room are dated and would benefit from these improvements.

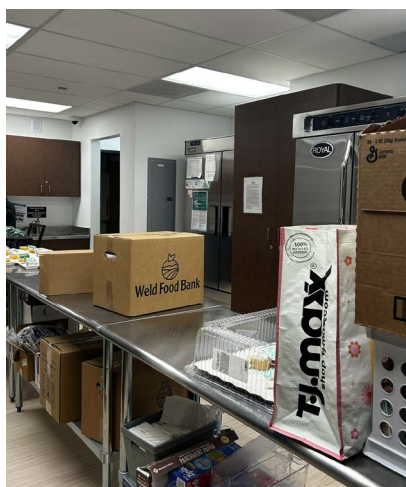
CATERING KITCHEN

As noted, areas of the building have recently been updated (kitchen, lobby). Areas in need of updates include the ill-child room and the three programmed rooms. Multipurpose room and STEAM classroom finishes and casework could be updated to better serve the functions of these rooms. The USA boxing certified gym is in overall good condition. Storage is limited throughout the facility. The gymnasium, added in 2005, is in good condition.

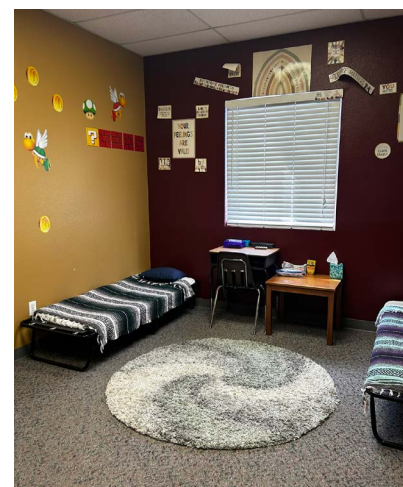
ILL CHILD AREA

Acoustics in the classroom/library are substandard for the needs of this space. Lighting in the classroom/library, ill-child room, and the STEAM classroom is inadequate.

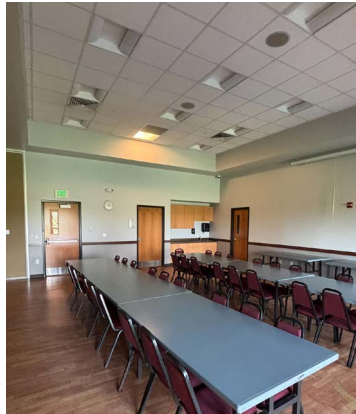
MEETING ROOMS

The warm water activity pool is in high demand for swim lessons and aqua fitness, therefore, limiting family and drop-in capacity. The fitness center and studio are heavily used, with growing demand. The downstairs functional fitness area supports personal training and overflow. The repurposed spinning room is popular, and according to staff they need 30–35 more bikes to meet demand. The childcare room has limited capacity but supports parent participation. The fieldhouse is the only gymnasium space and serves both programs and drop-ins. Staff noted that the existing, original sport court-type flooring in the gym will soon be replaced, eliminating the option for inline hockey. The two multipurpose rooms are booked weeks in advance for events and rentals.

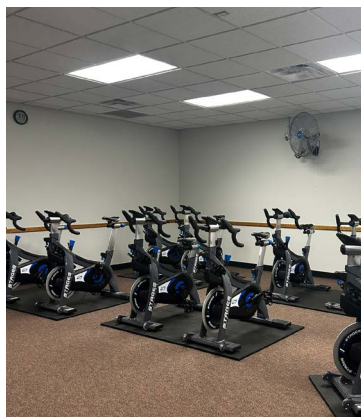
SPIN ROOM

The facility has several operational and design challenges. The main entrance lacks control at the primary guest vestibule and raises security concerns. Repurposed spaces, such as the spinning room and disconnected functional fitness area, have a poor layout and worn flooring. Both are difficult to supervise and control. Storage shortages affect programming areas, with staff occupying designated storage rooms as overflow offices. The senior room, intended for social interaction, is primarily used for meetings and is an uncomfortable space. In the natatorium, a rock structure/ drop slide is closed due to the following: using the structure requires taking lap lanes offline, and its activation necessitates additional lifeguard staffing. The structure obstructs the lifeguard's view from the office and also impedes airflow, negatively impacting air handling. It is recommended for removal. Deck

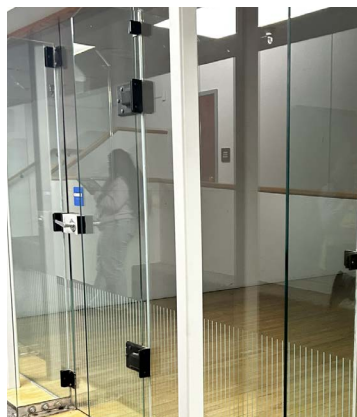
RACQUETBALL COURTS

Second-floor administrative offices have been updated but lack storage. Carpeted party rooms feel dated. Two racquetball courts are in fair condition; a third has been converted into a small climbing wall.

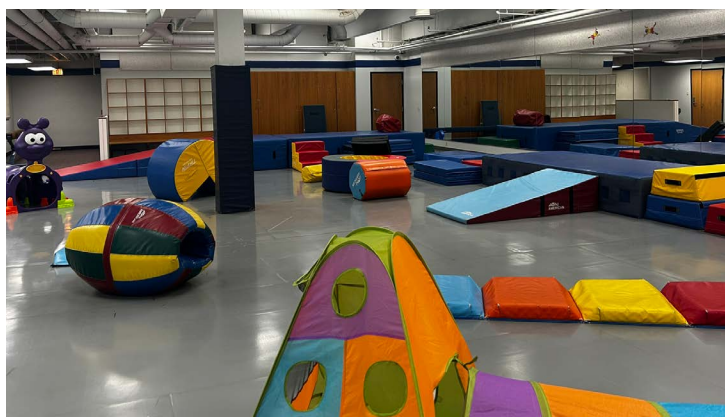
TUMBLING ROOM

**Flooring:** The concrete pool deck appears dirty despite pressure washing, with standing water due to inadequate drainage. Carpet in the lifeguard and staff areas is unsuitable for the natatorium’s wet, humid conditions and should be replaced with water-resistant flooring. The adjacent spinning and meeting rooms have worn carpet; resilient athletic flooring is recommended for the spin room. Flooring in the group fitness studio, Dance Room 1, and the tumbling room also requires replacement.
